ANALYSIS REPORT

Report Number: 88-003

Sample Submitted: Sandy soil from four TPS-63E radar sites.

PROGRAM:	TPS-63E	RAL REPORT NO.:	88-138
PART NAME:	BOARD ASSEMBLIES, WIREWRAP	NR NO.:	N/A
PART NO.:	SEE BELOW	SERIAL NO.:	SEE BELOW
MANUFACTURER:	WESTINGHOUSE	QTY.:	2
DATE RECEIVED:	09/26/88	DATE CODE:	N/A
ANALYSIS REQUESTED BY:	JOHN HOLDEN	PHONE:	5-4509
ANALYSIS CONDUCTED BY:	PAUL WANGLEE	PHONE:	5-6513
		DATE:	10/17/88

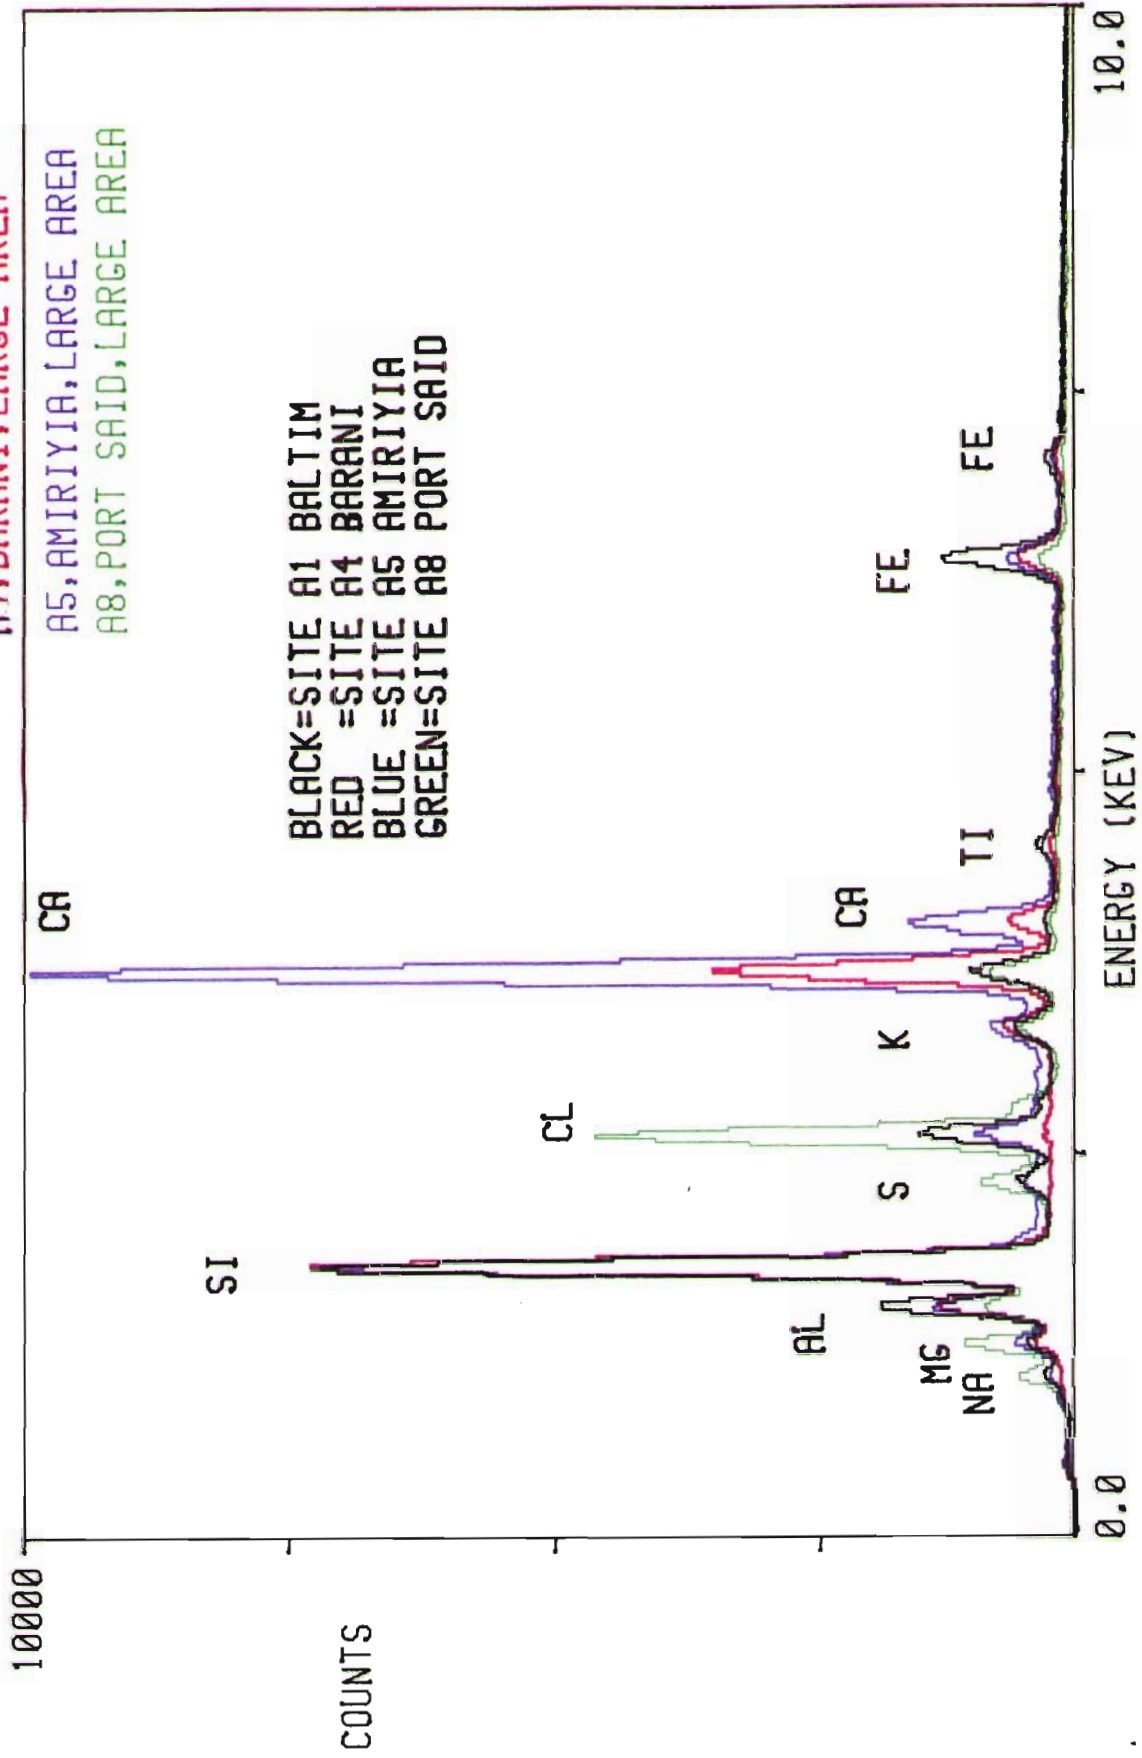
SAND A1, A4, A5 & A8 12/6/88

The amount of silicon remained relatively constant between samples which is understandable due to the prime constituent of the sandy soil in the area being SiO_2 . Calcium was found in greater amounts in the samples from Amiriya, Matruh, and Barrani possibly due to a closer proximity to the Mediterranean where more seashells would be ground up into the sandy soil. The samples from Port Said and Matruh contained a far greater amount of chlorine and magnesium than the other samples. This may be due to a closer proximity of the radar site to wells or briney areas.

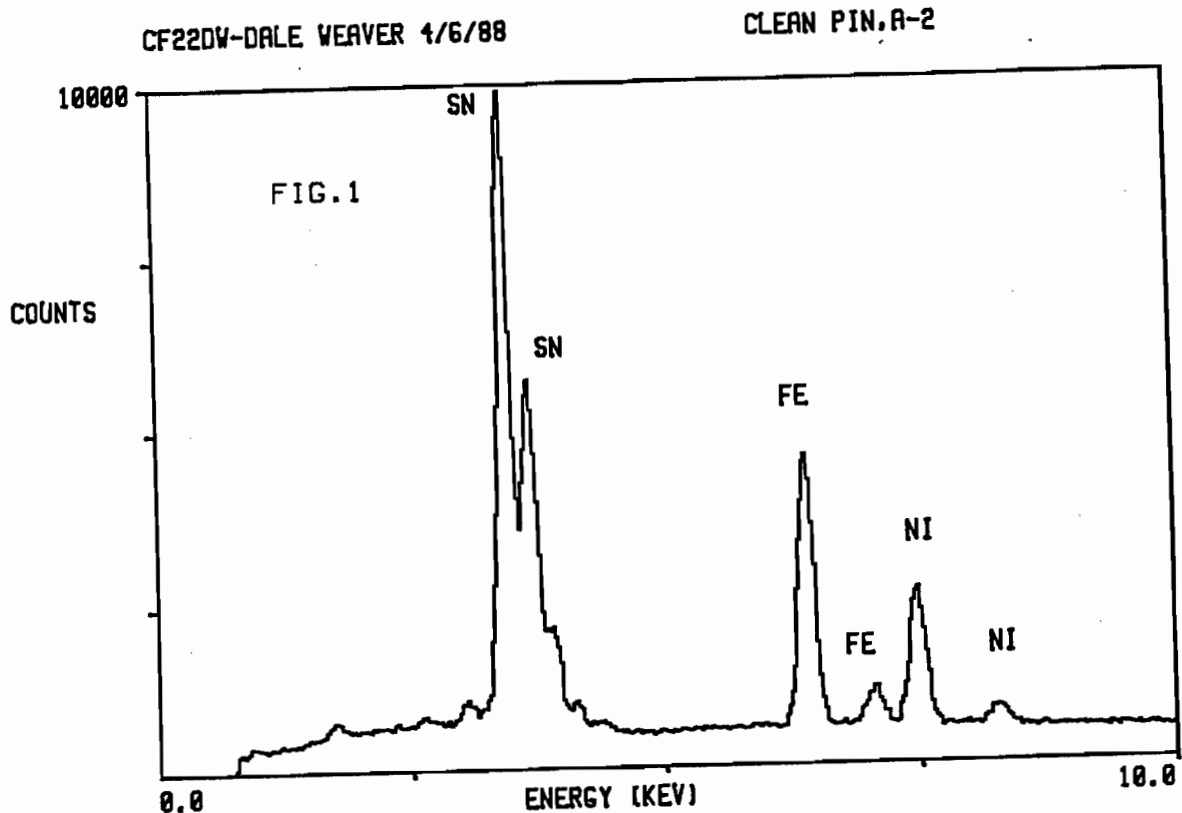
Figure 1, below, is the x-ray spectrum of a clean surface on an uncorroded lead. The lead appears to be coated with only tin. The iron and nickel is from the base metal.

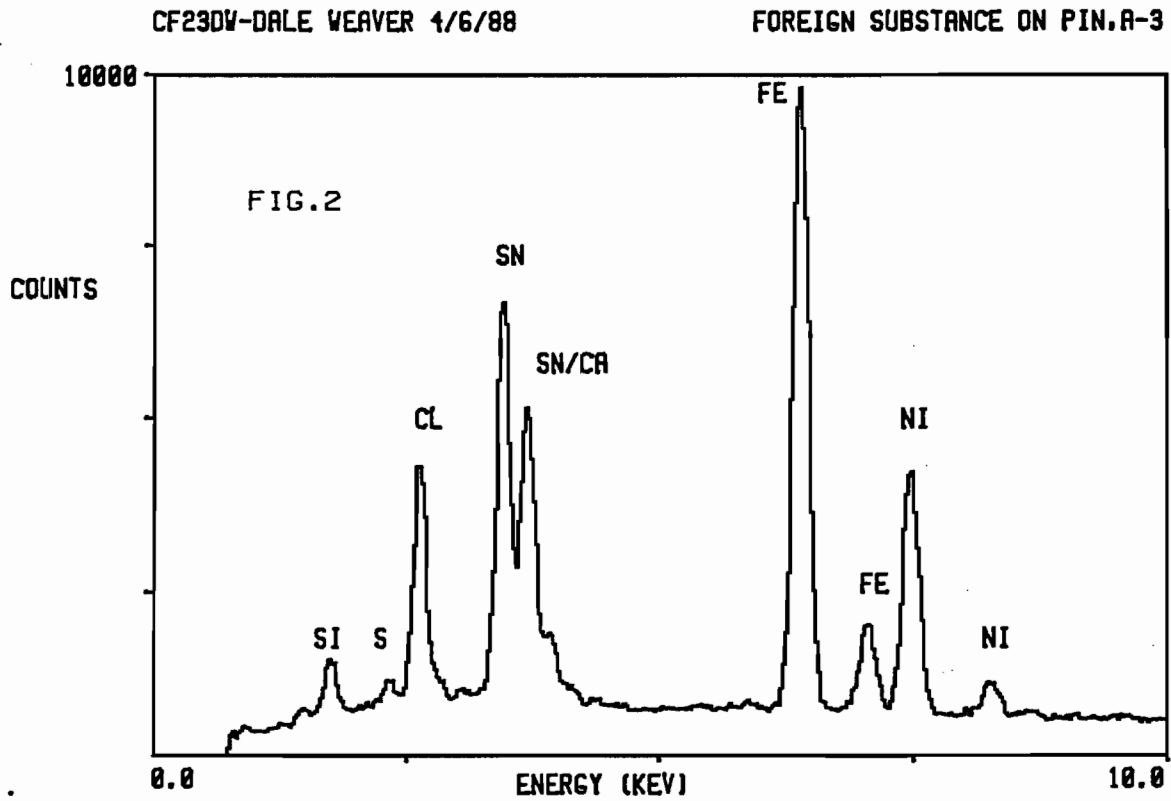
Figure 2 is a spectrum of a corroded area on a lead. This spectrum contains large amounts of iron and tin, with lesser amounts of nickel and chlorine, and trace amounts of silicon, sulfur and calcium.

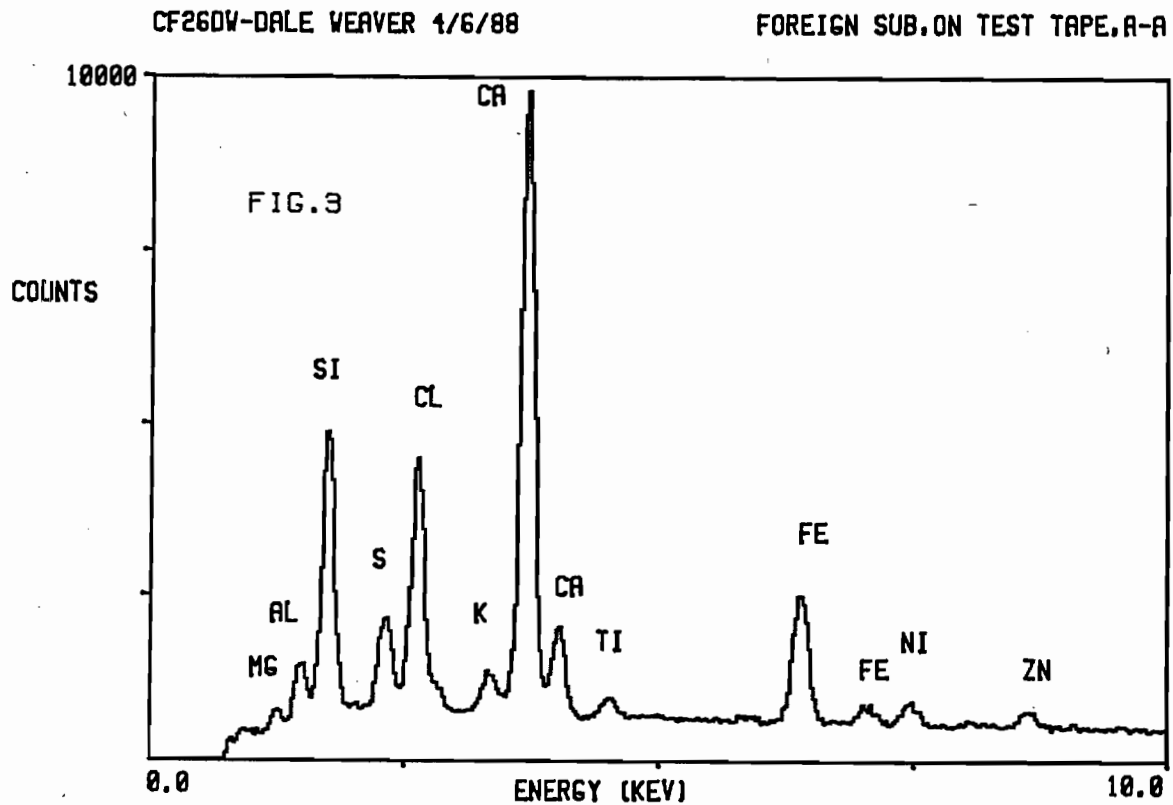
Figure 3 is the spectrum of some of the residue removed from the body of the IC. This material contains large amounts of calcium, lesser amounts of silicon, chlorine, and iron, and trace amounts of aluminum, magnesium, sulfur, zinc, potassium, titanium, and nickel.

The elemental composition of the residue in figure 3, removed from the body of the IC, suggest the prescence of residues left from the evaporation of ground water. Since the amount of calcium and silicon present in the sample is greater than the amount of chlorine, the residue could not have come from sea water. The porpotions of the constituents in the sample also seems precludes the idea that condensation could have been the source of the water.

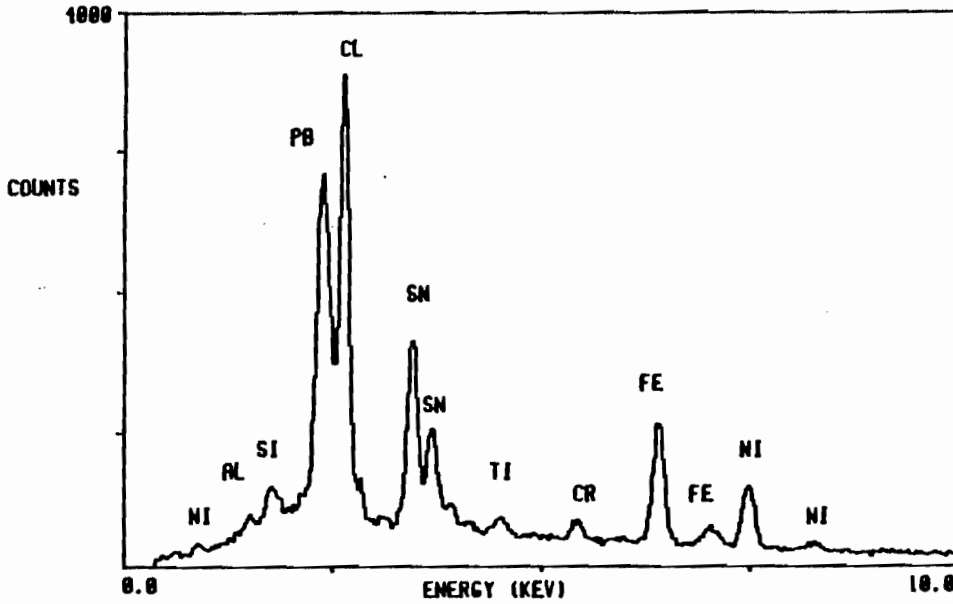
FIGURE 2

EDXA spectrum of
"reddish brown"
particle.

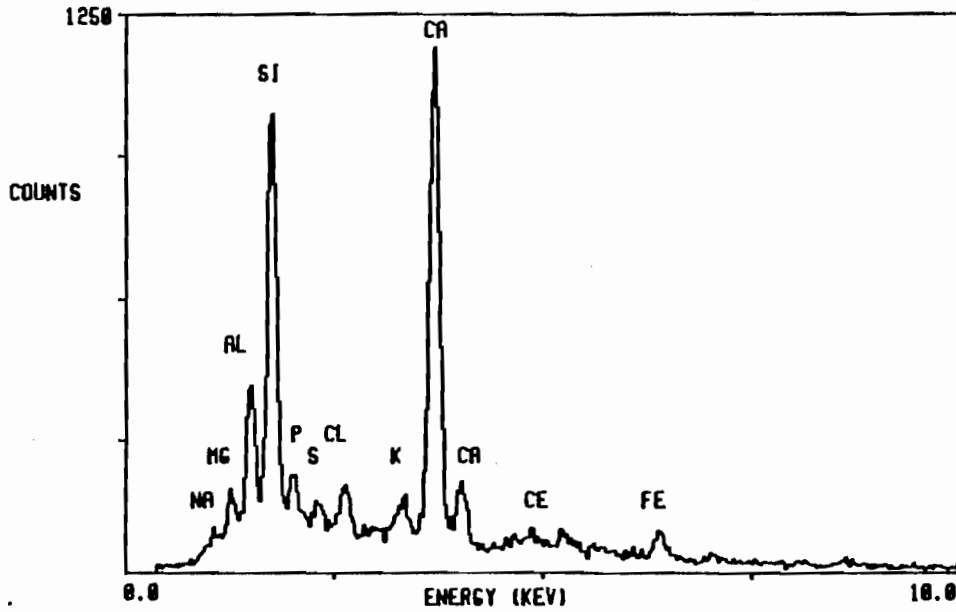
FIGURE 3

EDXA spectrum of "light brown" particles from U95.

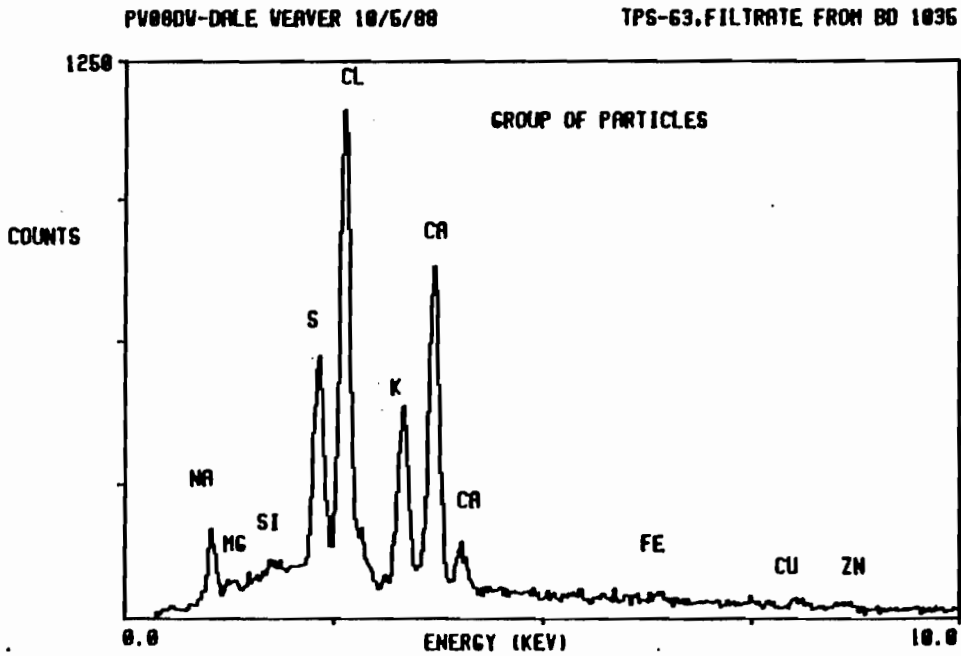
FIGURE 4

The fourth sample was a solution containing the water soluble elements from the ECM alarm board (see photographs 3 and 4). The sample was collected by spraying the ECM alarm board with de-ionized water, collecting the run-off and filtering the run-off. The filtrate contained sodium, chlorine, calcium, sulphur and potassium. Sodium chloride is salt and the other elements are frequently found in sand or dirt (see figure 4).

EDXA spectrum of
ECM alarm board
filtrate.
