Substrate Cleanliness for Gold Ball Wire Bonding

SCOTT E. DAHNE

Litton Systems, Inc.
Amecom Division
5115 Calvert Road
College Park, MD 20740

July 11, 1986

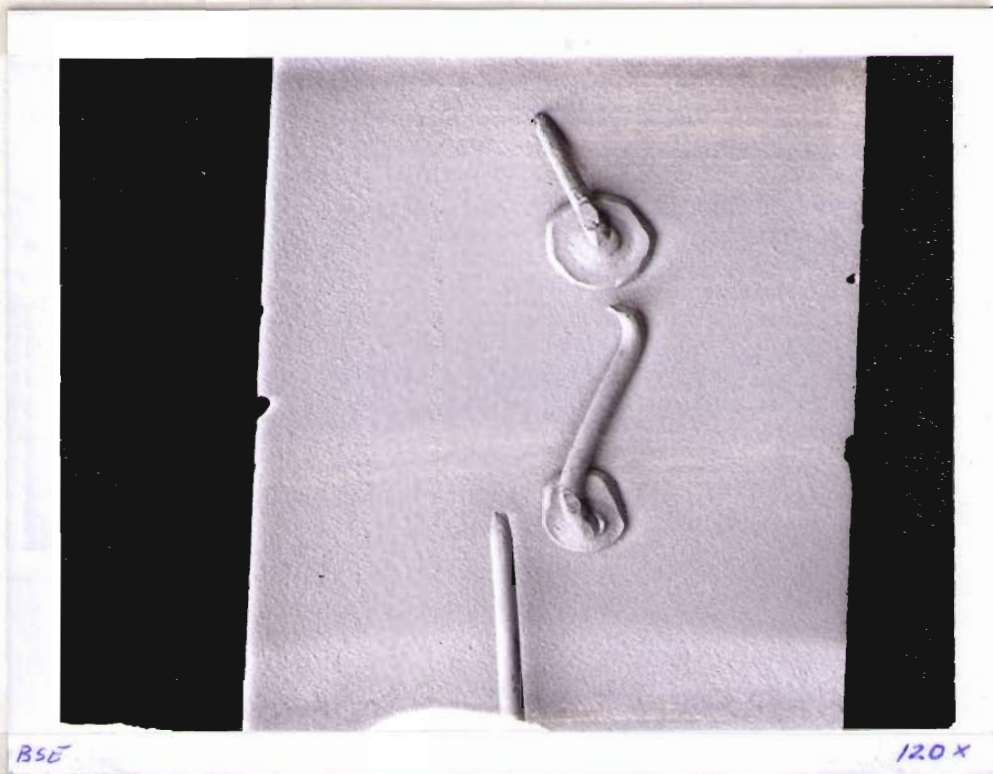
Fig. 1

In order to evaluate the gold metallization on the substrate where bonding would occur (henceforth called the substrate surface), Scanning Electron Microscopy (SEM) analysis was performed on a clean substrate directly out of the packaging material (Fig. 1). The new substrate surface exhibits no signs of contamination or surface irregularities. When 1.0 mil gold wire was bonded to this surface, the only failure modes identified were attributed to surpassing the break strength of the wire itself (Table I). Theoretically, this would be considered a cohesive failure. The standard deviation associated with the bond pull results indicates a statistically accurate sample and these results will be used as a control group for the remaining portions of the investigation. Shear test results on this sample (Table II) showed that 85% of the ball bonds were cohesive failures (Fig. 7), indicating that the ball bond to substrate interface was reliable and the gold/gold weld was correctly formed.

NEW SUBSTRATE (CONTROL)

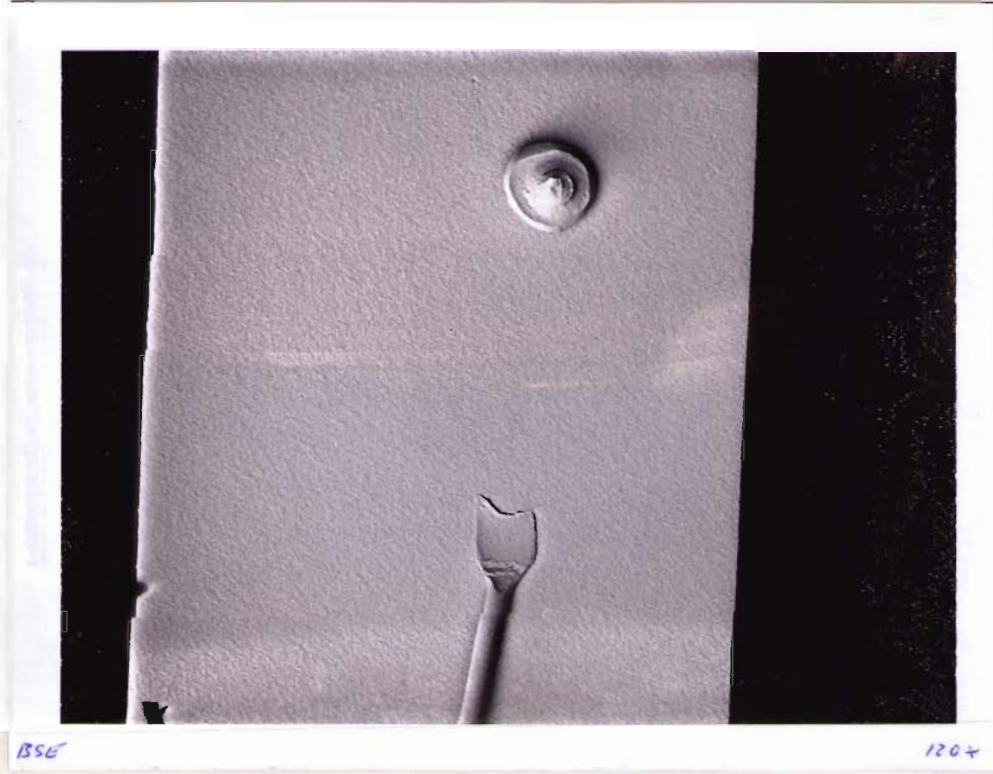
Fig. 2

Additional testing of the cleaning method was conducted on the control substrate to determine the effects of the process on an "uncontaminated" substrate. SEM analysis of the surface revealed no visible changes (Fig. 2), however, there was a complete elimination of adhesive failures in the bonds. Based upon these results, it appears that the use of the new cleaning method is beneficial on new parts to remove any surface contamination left during manufacture and packing of the substrates.

SUBSTRATE SPRAYED WITH 1,1,1 - TRICHLOROETHANE FOR 20 SECONDS AT 30 PSI

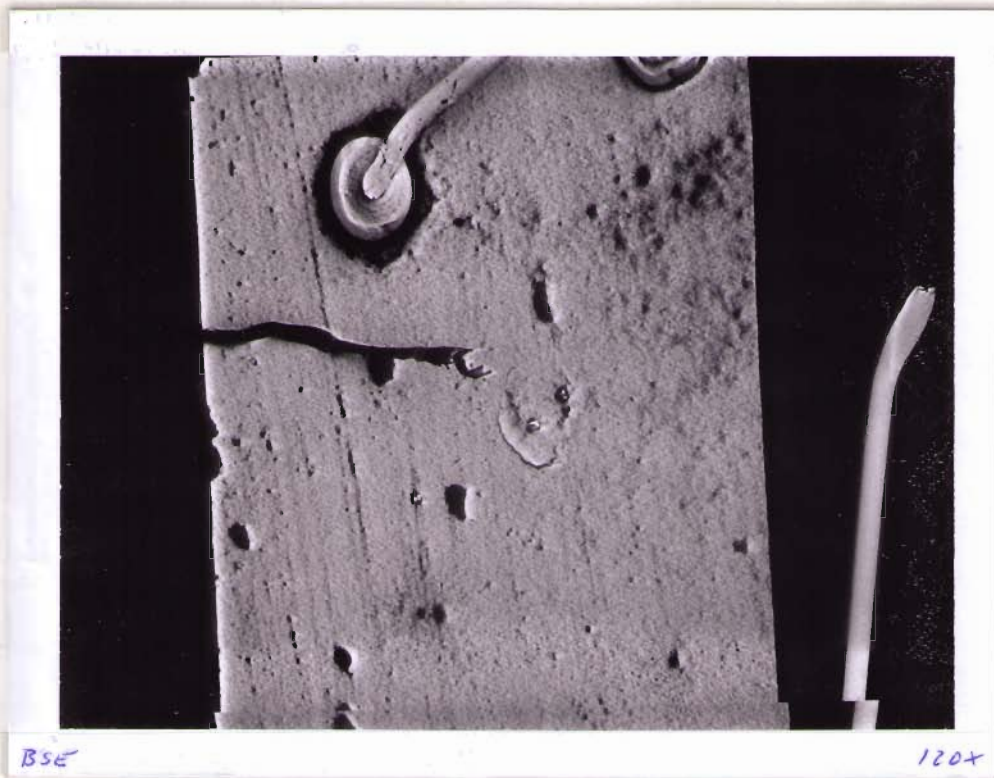
Fig. 3

Introduction of surface contaminants to a substrate surface was accomplished by picking the substrate up with a bare finger. This technique was used since it is the most probable cause of contaminant introduction to the substrate due to the current in-plant handling procedures. SEM analysis of the substrate surface after being picked up (Fig. 3) indicates a high degree of surface contamination and surface topography changes. Further analysis revealed that the identifiable constituents of the contamination were organic in nature. Attempts at placing wire bonds on this surface were extremely difficult and yielded only a 30.9% success rate at the bonding operation. Pull testing of the successful bonds revealed that the primary mode of failure in this case was also cohesive failure, however, shear testing revealed that 86.6% of the ball bonds failed as a result of adhesive failure between the ball and the substrate (Fig. 6).

The contamination and particulate matter are easily seen on the test substrate (Fig. 3). Once the test substrate has been cleaned using the solvent/air pressure method previously described, the surface (Fig. 4) is free of any visible contaminants and appears to have the same topography as the control sample (Fig. 1). Bonding to the newly cleaned surface was considerably easier with an 85% success rate at the bonding operation as compared to the previous 30.9%. Bond pull testing revealed a return to the higher strengths seen in the control substrate and shear testing indicated primarily cohesive failures with a closer sample grouping as indicated in the standard deviations.

SUBSTRATE WIPED ACROSS WITH FINGER TO INTRODUCE ORGANIC CONTAMINATION

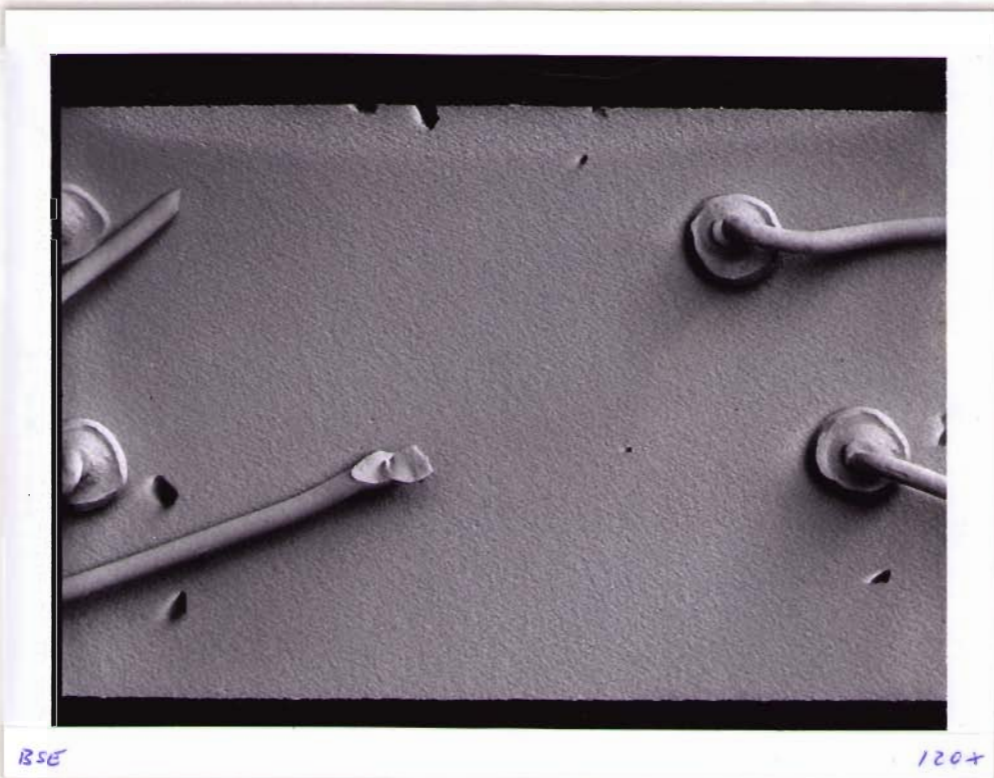
Fig. 4

SUBSTRATE WIPED ACROSS WITH FINGER TO INTRODUCE ORGANIC CONTAMINATION FOLLOWED BY 1,1,1 - TRICHLOROETHANE SPRAY FOR 40 SECONDS AT 30 PSI

In order to determine whether the surface contamination and topography changes were the primary cause for the change from a cohesive to an adhesive failure mode in the bonds, a method was developed to return the substrate to a condition as close to the control substrate as possible. 1,1,1-Trichloroethane was chosen as the solvent to remove organic contamination from the gold surface due to its high activity level. Application of the solvent was accomplished by using an airbrush with 30 PSI of pressure. The combination of solvent and pressure would either dissolve or dislodge any contaminants on the substrate surface.

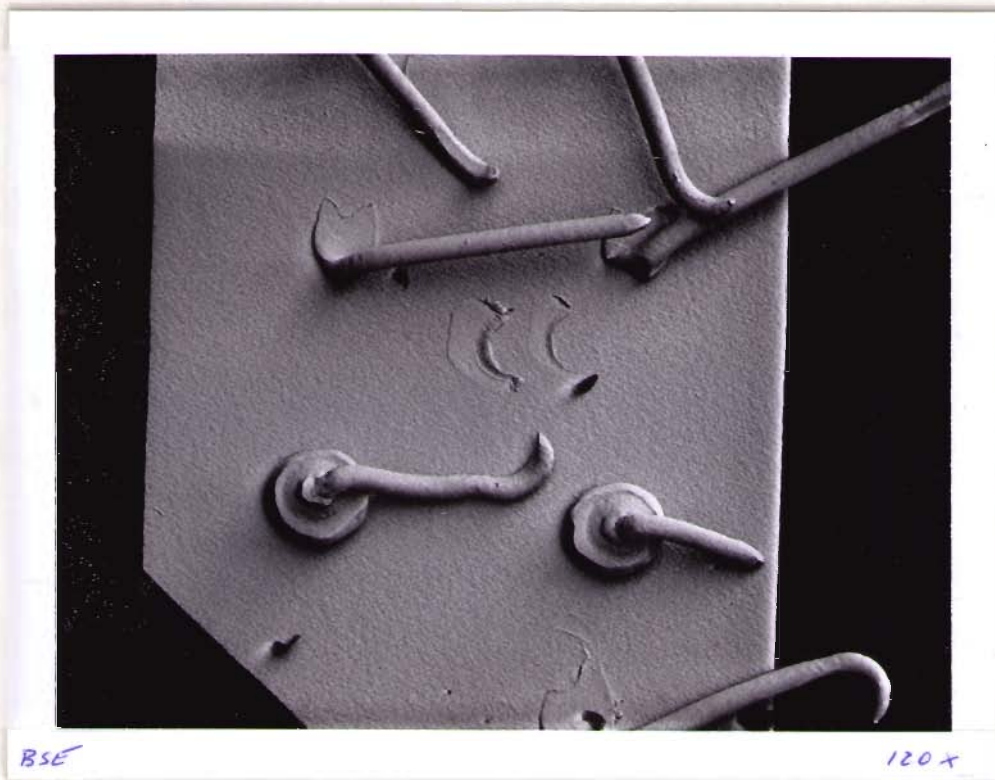
Fig. 5

Having determined a method for cleaning the substrates, the necessity now exists for a method of handling them without leaving any contaminants on the surface or affecting the surface topography. The use of latex finger cots was evaluated for handling by using them to pick up and wipe across a substrate surface. Analysis of the surface which was contacted by the finger cots shows no evidence of contamination (Fig. 5) or topography changes and bond pull and shear strength testing reveals a level of reliability consistent with the control substrate.

SUBSTRATE SPRAYED WITH 1,1,1 - TRICHLOROETHANE FOR 20 SECONDS
AT 30 PSI FOLLOWED BY WIPING ACROSS TRACES WITH A FINGER COT

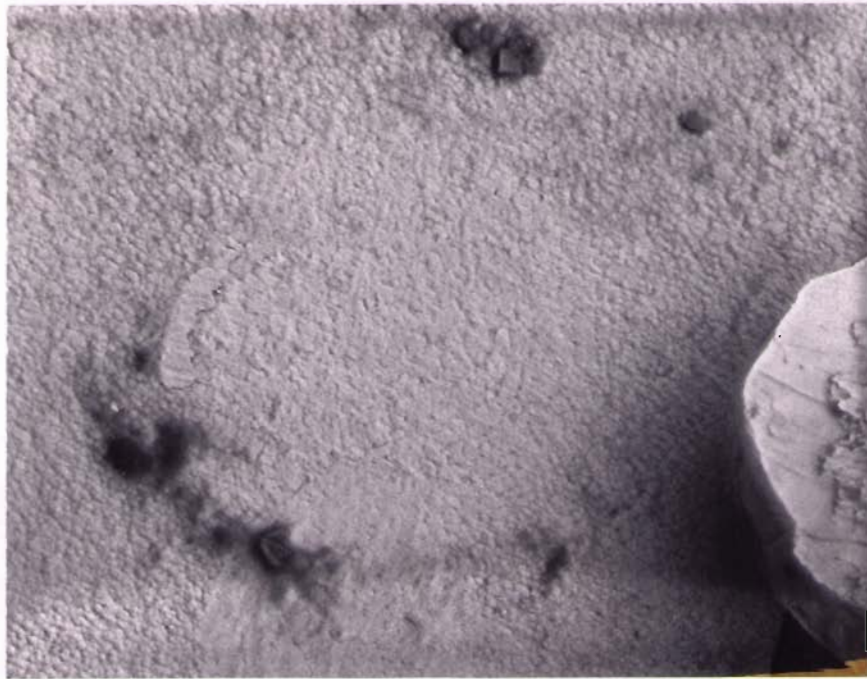
Fig. 6

ADHESIVE FAILURE FROM SHEAR TEST OF BALL BOND

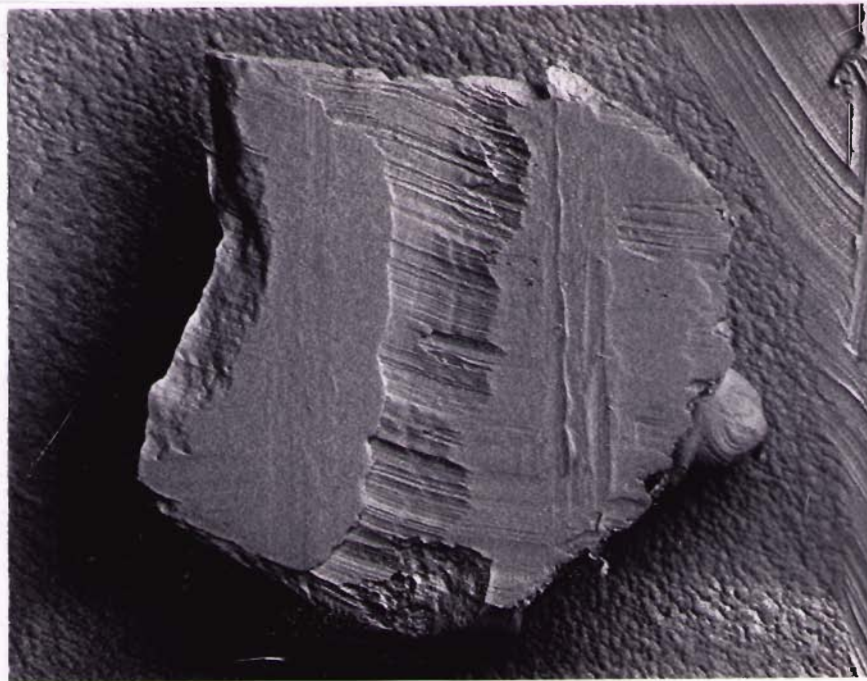
Fig. 7

COHESIVE FAILURE FROM SHEAR TEST OF BALL BOND
